Upper Hunter Mining Dialogue

Final and Temporary Rehabilitation Principles and Commitments 2016 Report by Coal & Allied - MTW and HVO

May 2017

2016 Reporting – Coal & Allied (Includes Hunter Valley Operations and Mt Thorley Warkworth)

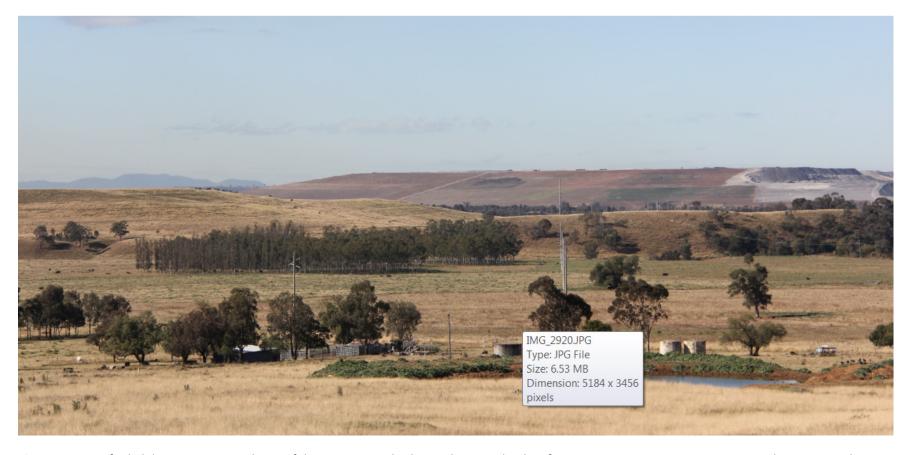
Figure 1. View of rehabilitation on outer slopes of dumps at HVO Cheshunt. Photograph taken from a vantage point on Lemington Road, Ravensworth.

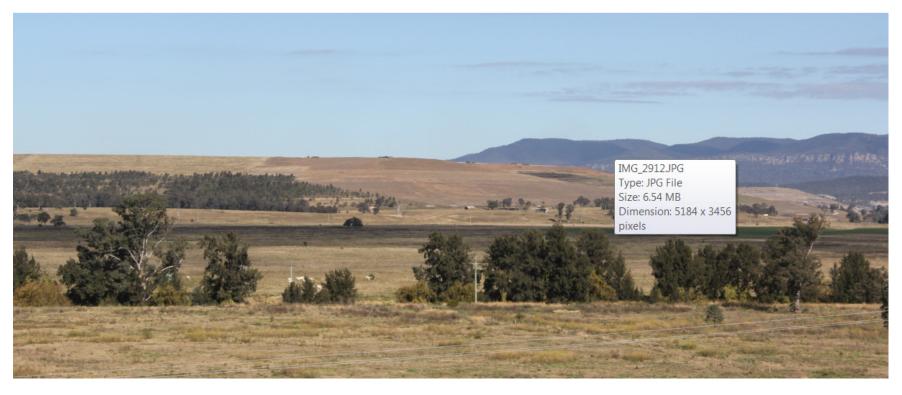
Figure 2. View of rehabilitation on outer slopes of dumps at HVO Cheshunt. Photograph taken from a vantage point on Lemington Road, Ravensworth.

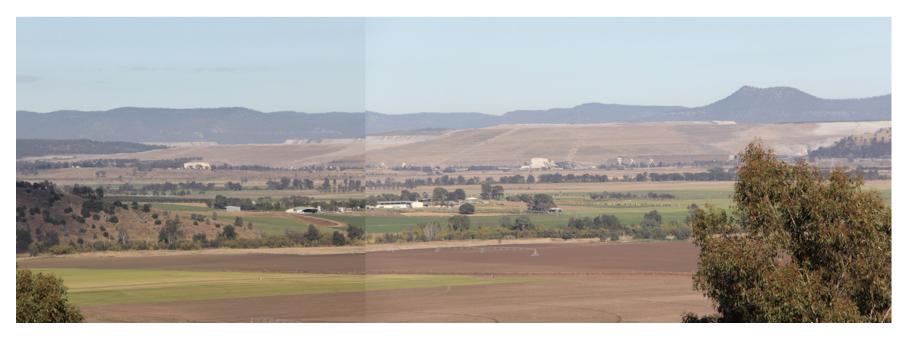
Figure 3. View of rehabilitation in MTW South Pit North and South Pit South undertaken between 2013 and 2016. Photograph taken from Hambledon Hill, Singleton.

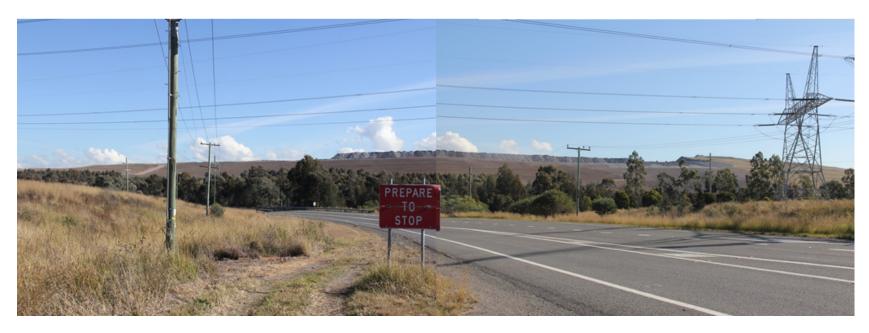
Figure 4. View of rehabilitation in MTW South Pit South undertaken during 2016. Photograph taken from Putty Road, Mt Thorley.
